SAFETY CRITICAL REPORT 2014 - 001

Site: 000310
Address: Old Lakeshore Road Over Cull Drain Bridge
Inspected By: M. Serban
Inspection Date: July 31, 2014

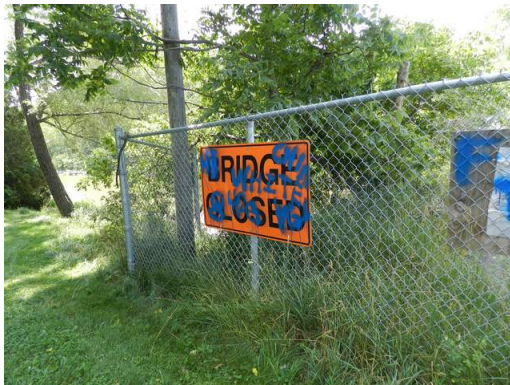
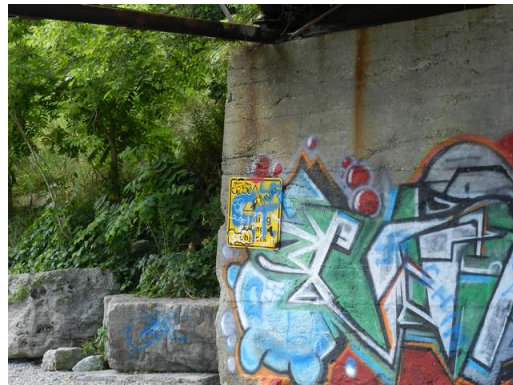
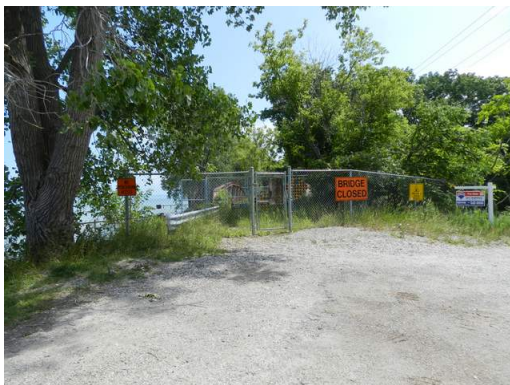
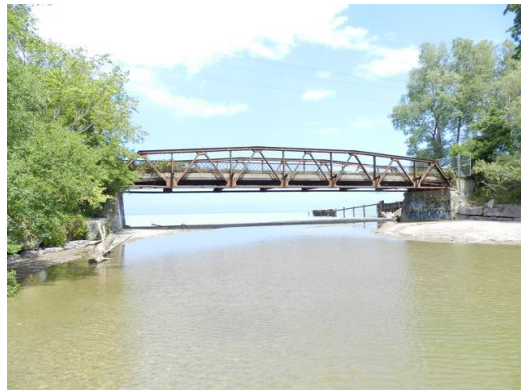
All warning signs at the east are in poor condition and some of the signs at the west are also damaged (graffiti).

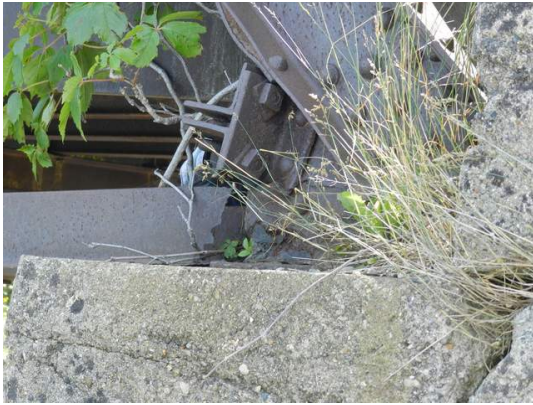
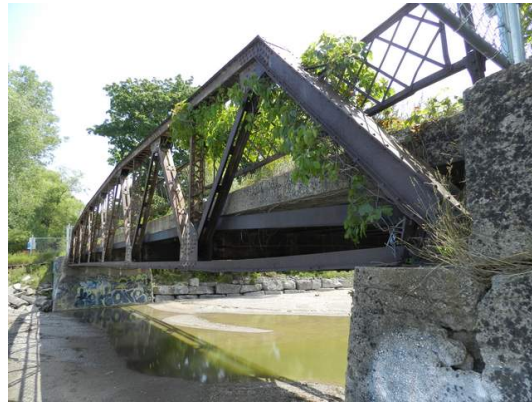
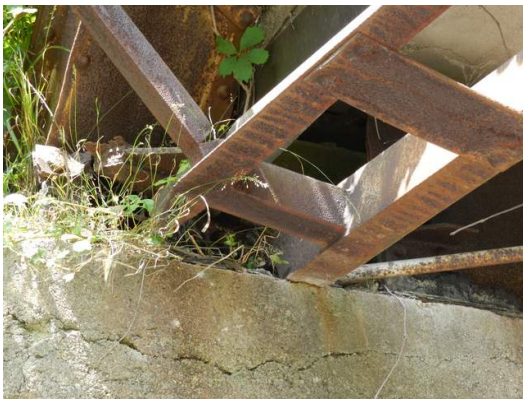
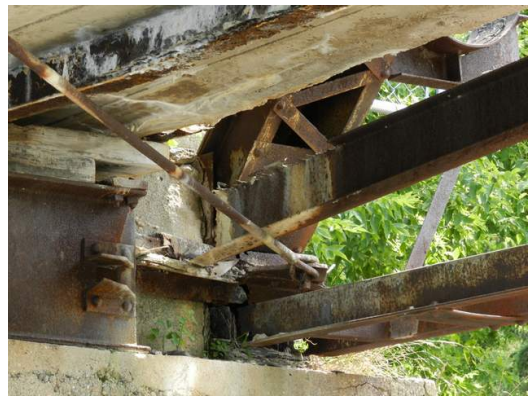
The bottom chords are completely severed at the west end while at the east they are almost completely severed. The top chords are buckled.

URGENT ACTION REQUIRED – This superstructure should be removed immediately. Partial or total collapse may occur even as a result of high winds.

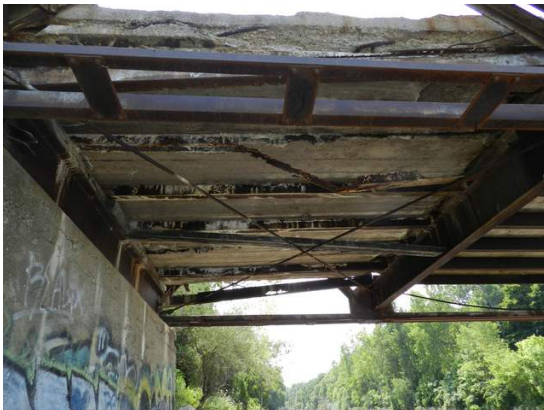
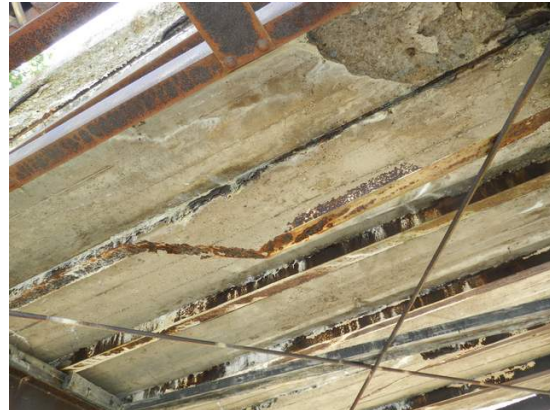
Stringers at the east end are in very poor condition as is the concrete deck which poses at the very least an overhead falling debris hazard.

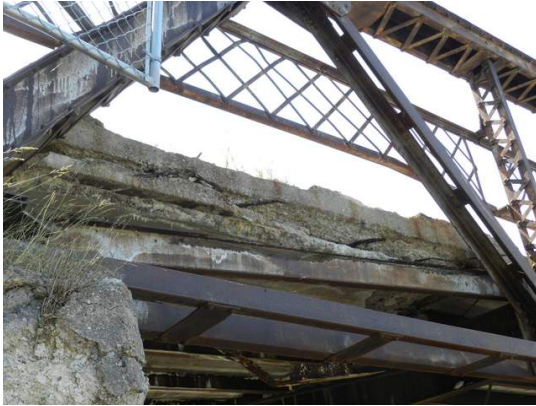
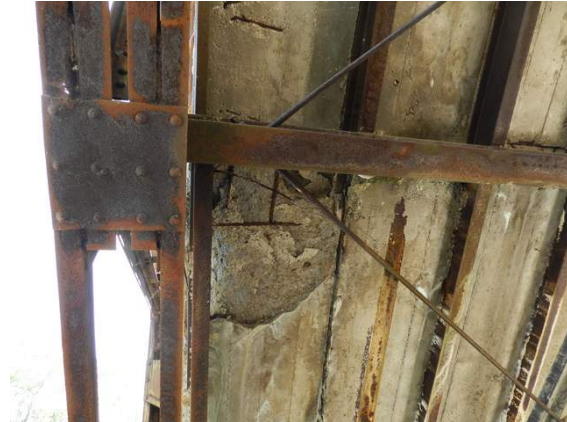
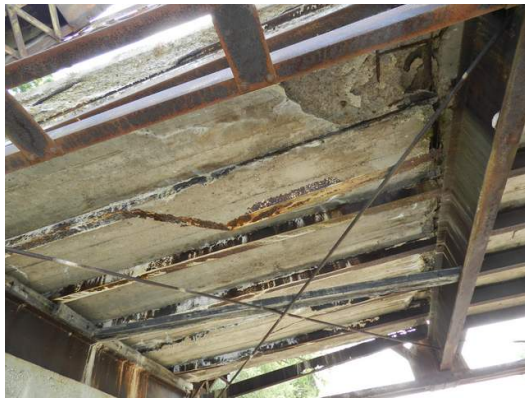
Both end sections of the deck have dropped together with the floor beams on the bearing seats as the floor beams are completely detached from the truss (failure of these deck sections could trigger collapse of the entire superstructure). The east section of the deck is in an advanced state of deterioration.

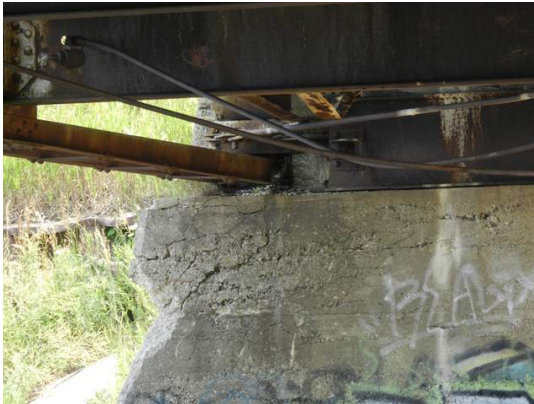
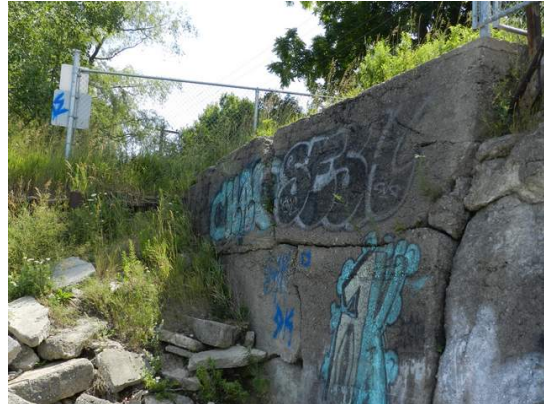
The northeast bearing seat has failed and the northeast wing wall should be partially removed as well.
